Working with Nature – a work in progress

(in an age of “encroaching humans” and “encroaching seas”)

Jim Dahm
Eco Nomos Ltd

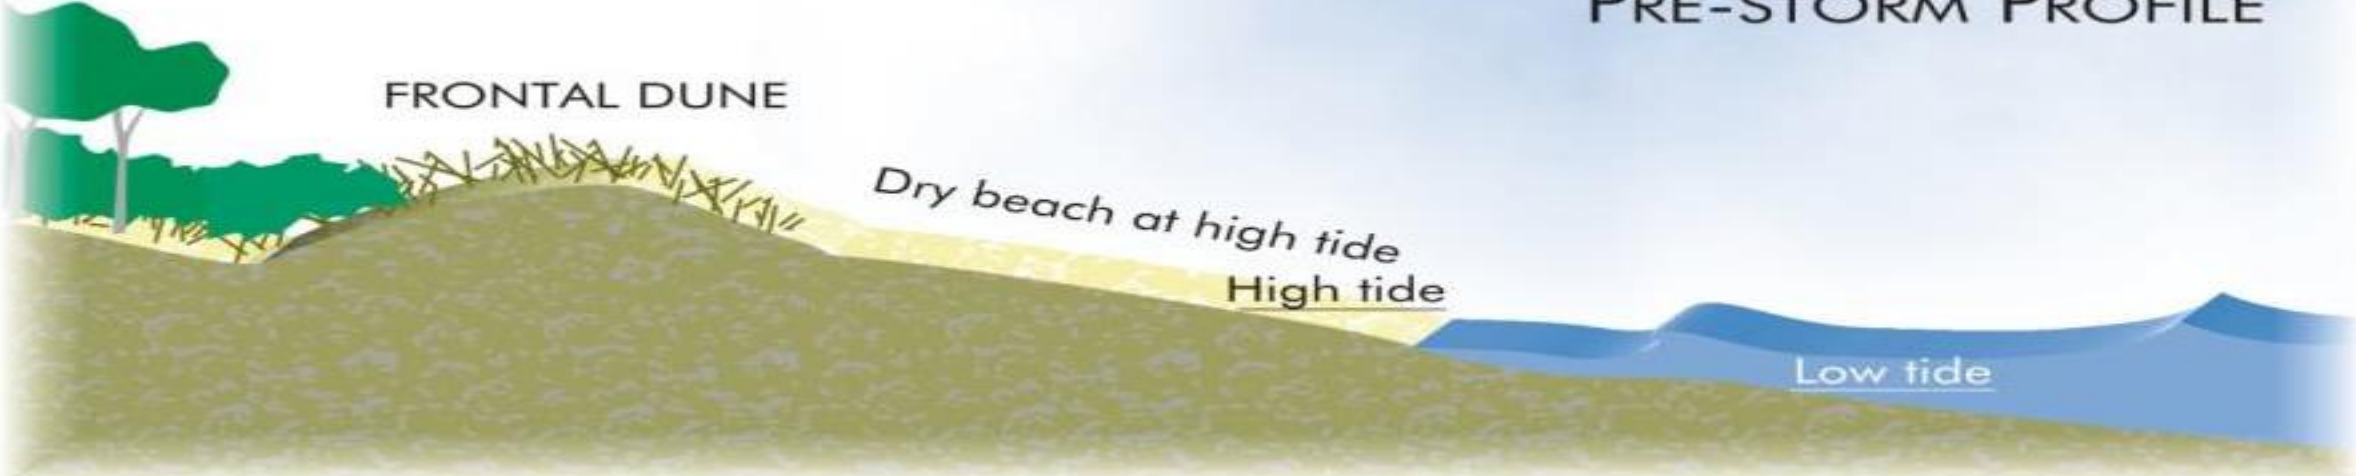
PRE-STORM PROFILE

- Sandy shorelines often fluctuate over time – so dunes experience periods of erosion and periods of natural shoreline recovery
- Dunes are an integral part of the total beach – sand exchanges between the dune and the beach. Dunes can be viewed as a beach’s “savings account”
- The width of dune is also a useful measure of the resilience of the beach to future change (including climate change)
- Particular native sand trapping vegetation (spinifex and pingao) play a critical role in natural dune repair after erosion.
- So, on fluctuating shorelines, dunes provide a natural self-repairing barrier against coastal hazards (inundation and erosion)
- BUT it is not about “stopping erosion” – the dunes come and go; need adequate space for a sustainable dune

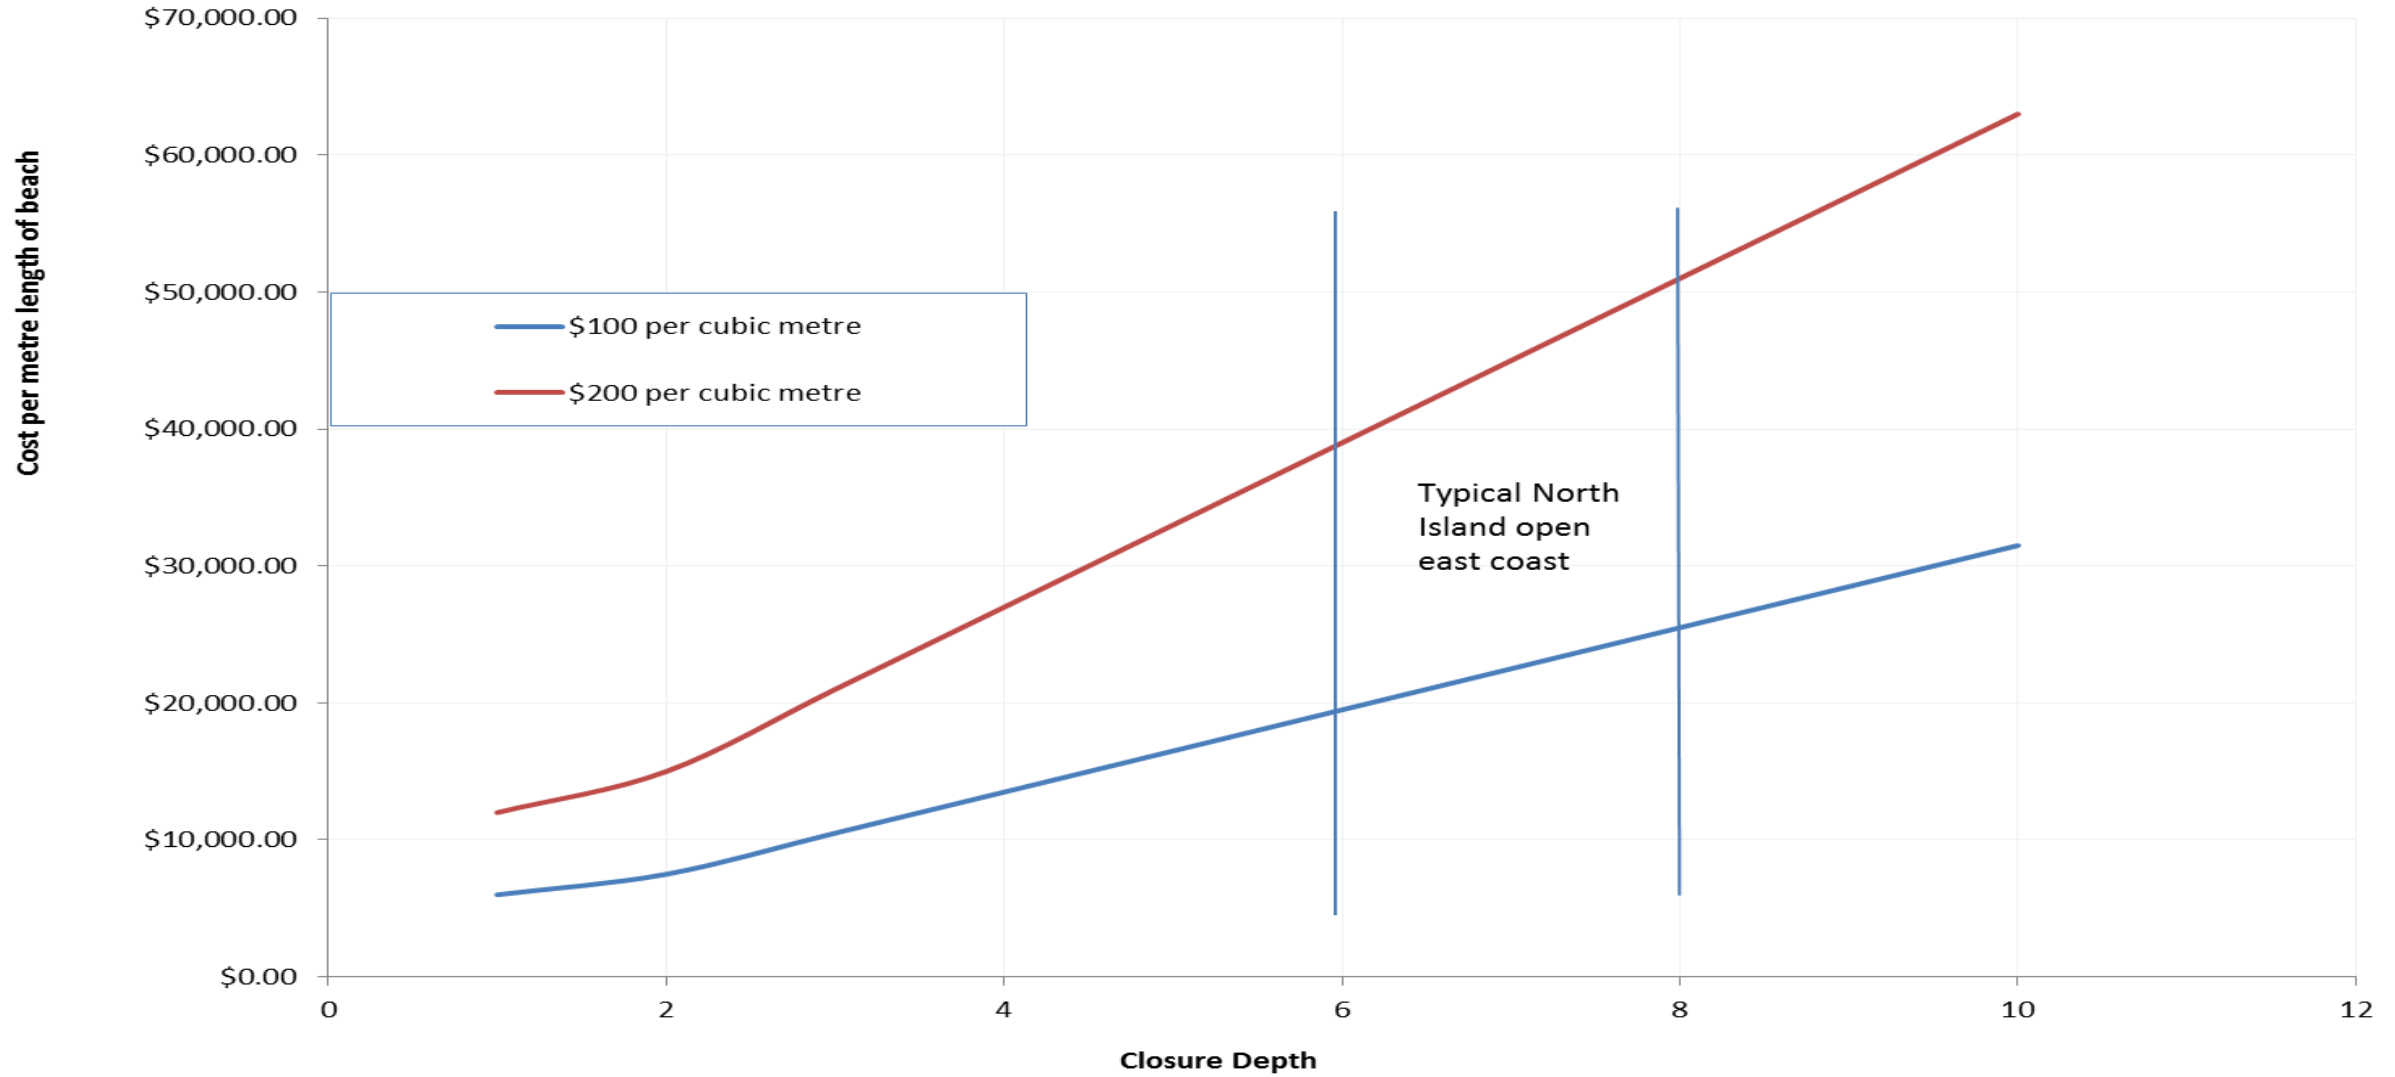
Beach Nourishment – Indicative Example showing increasing volumes required as Closure Depth Increases
