Restoring a Native Coastal Forest Sequence in North Canterbury: Te Kōhaka o Tūhaitara Trust and Coastal Restoration Trust Final Project Report

**David Bergin and Michael Bergin
Coastal Restoration Trust of New Zealand
June 2025**

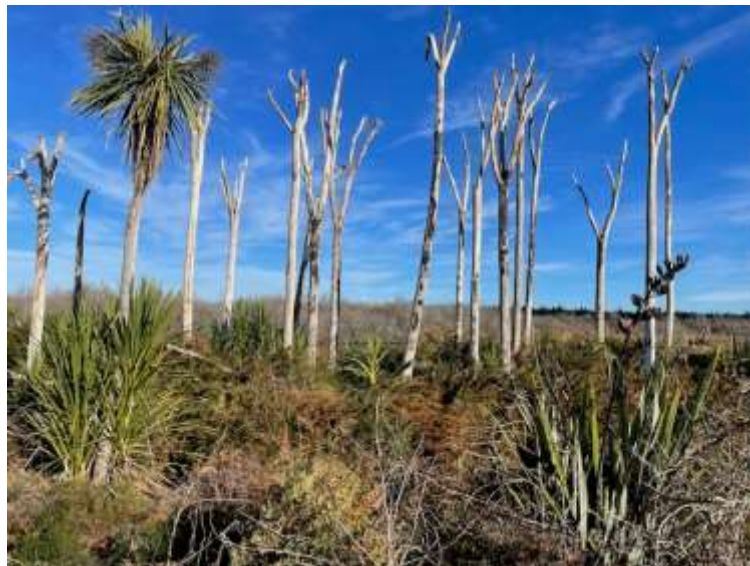
Fire damaged stand of ti kouka planted adjacent to the Tūtaepatu Lagoon with some recovering and regrowth of dense bracken.

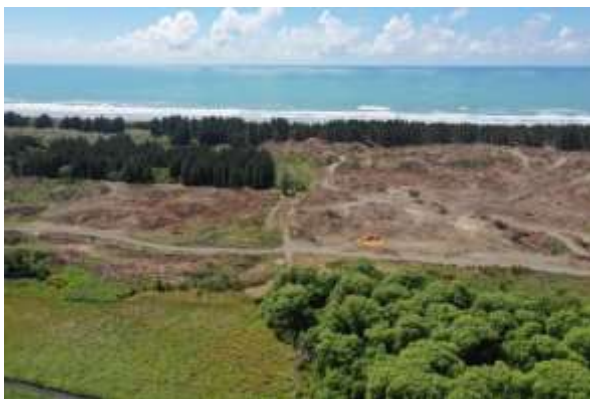
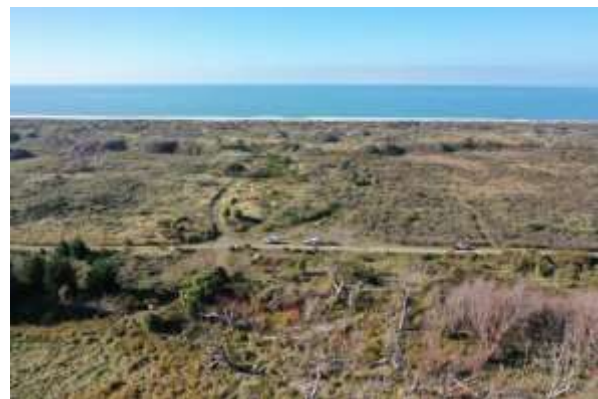
View seaward before the transect project started and the land cleared of slash. Note the willows in the foreground before poisoning (left – photo November 2018). Post salvage and removal of burnt pine after fire (right – photo taken May 2025). The pine forest has been recently felled leaving a limited protective buffer.

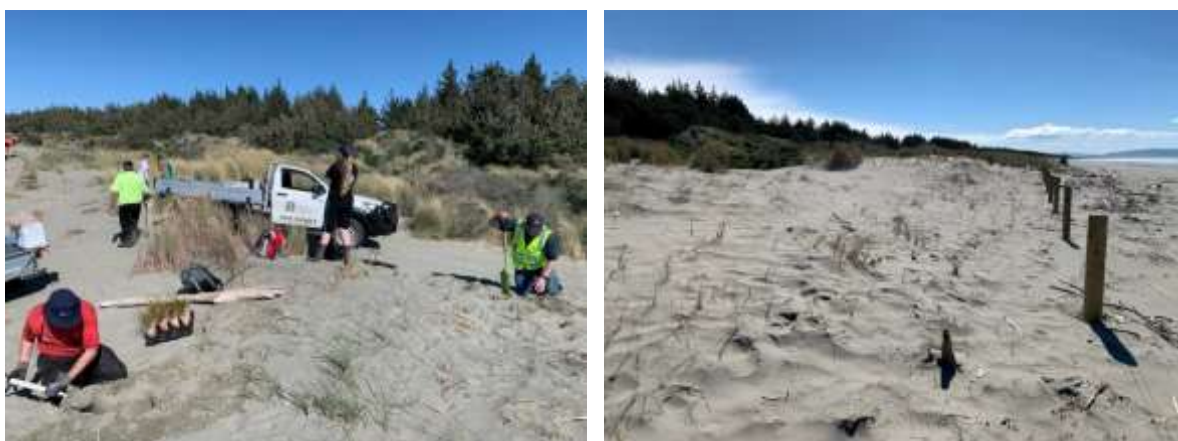
Planting of native sand binders spinifex and pingao on the foredune cleared of marram grass in September 2021 at the seaward end of the transect (left). The site was fenced to reduce trampling damage from beach users (right).

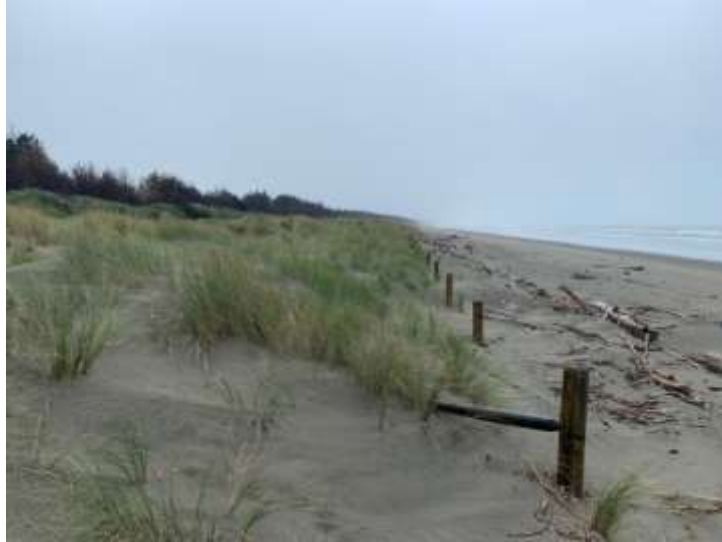
A dense sward of spinifex developed within two years of planting, while pīngao suffered severe browsing from rabbits. The foredune was unaffected by the fire in late 2022, as evident from the burnt pines visible in the background (photo taken May 2023).

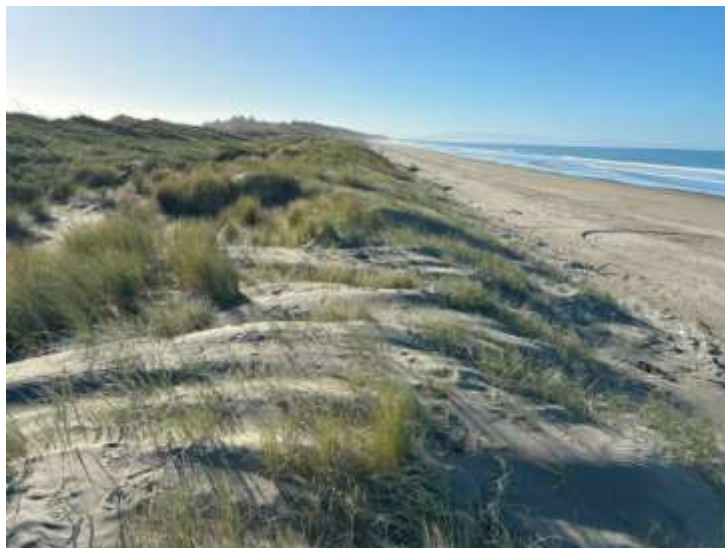
Over the past four years, the spinifex-dominated dunes have built a low-angle foredune with substantial sand accumulation, burying the fence (right – photo taken May 2025).

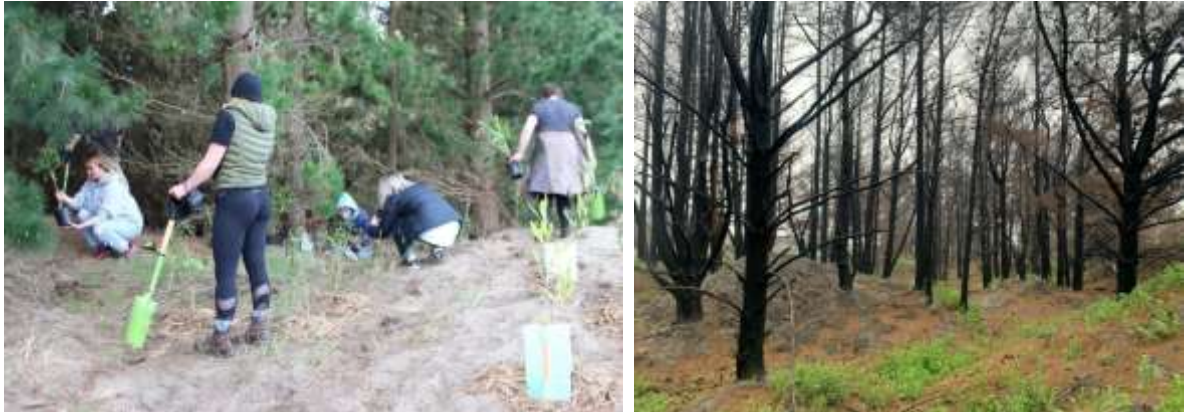
Interplanting of native shrub hardwoods within gaps and along edges of the existing pine forest, September 2020 (left). While these seedlings benefited from the shelter of the pines, all planted sites within the transect were lost due to the fire that destroyed 160 ha of the park in late 2023 (right – photo 4 months post fire).

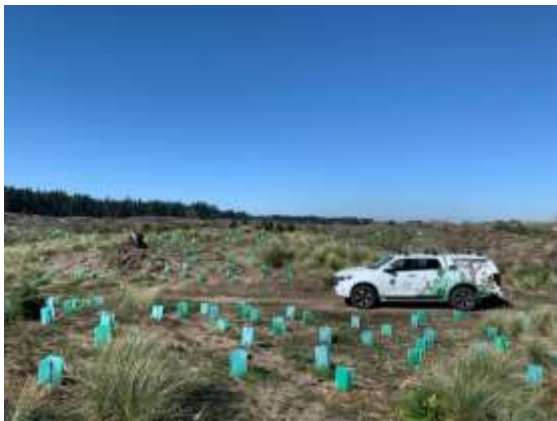
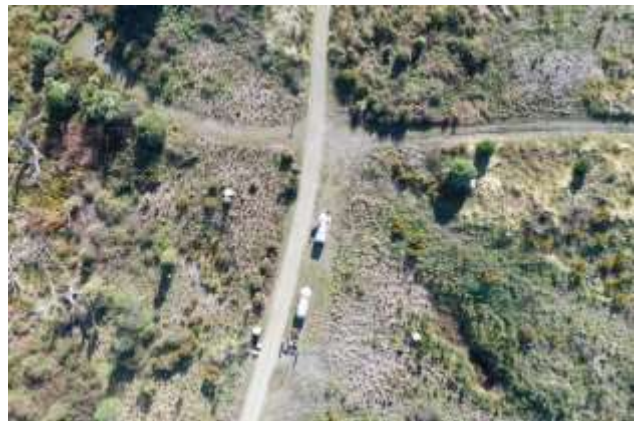
With support from Trees That Count, a further 10,000 native seedlings have been planted within the transect following the fire (left). These plantings have been planted in clusters as part of a continued planting and weed control program resulting in scattered mixed aged plantings (right).

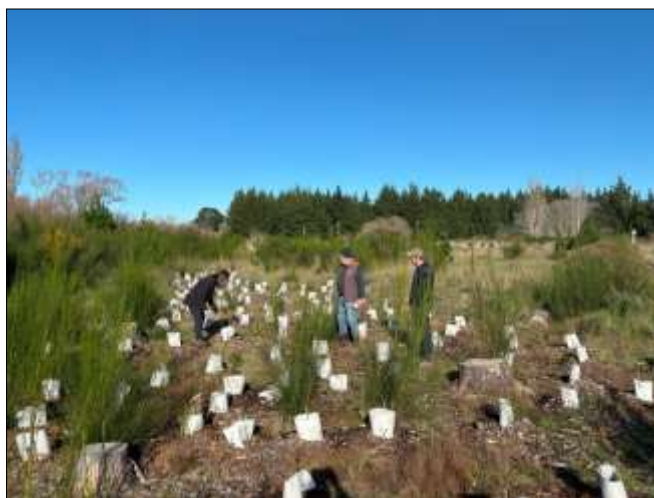
Inspection of the Gladstone Road totara seed island planting site in May 2025 with the Te Kohaka o Tuhaitara park rangers two years after planting.

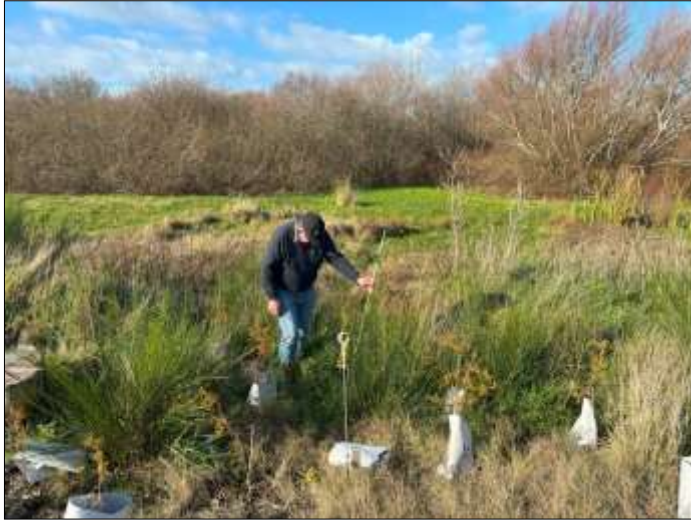
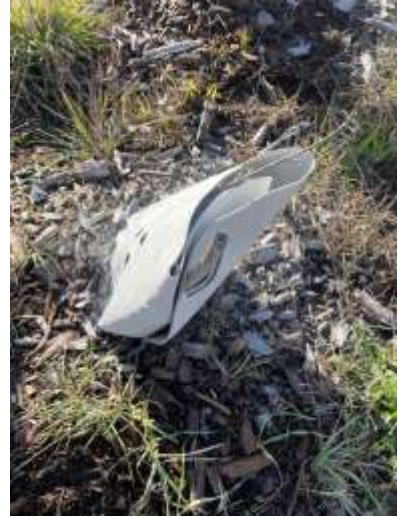
Remeasurement of the planted native seedlings in a more sheltered seed island site. Note the totara which have a higher survival rate and better growth performance likely due to the increased shelter provided by the surrounding broom. Collapsing cardboard tree guards (right) with only one supporting bamboo stake are contributing to poor performance.

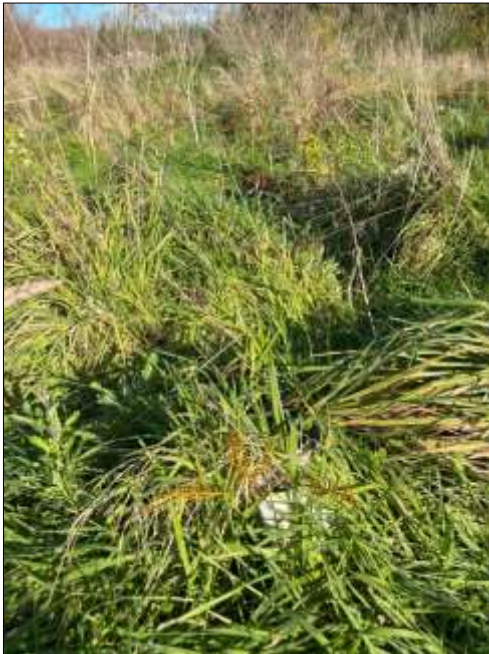
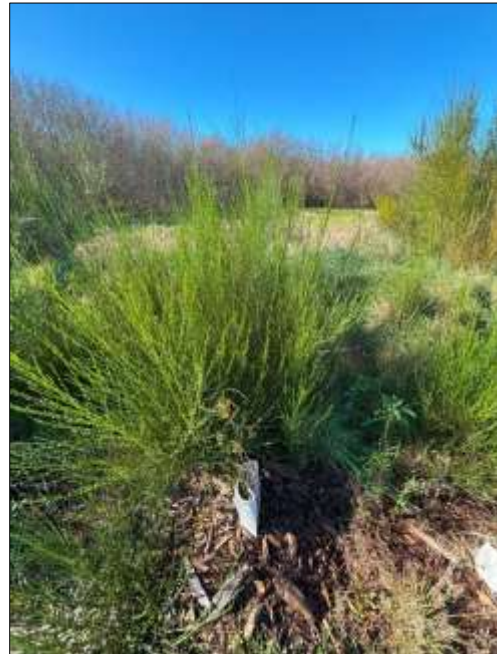
Surrounding vegetation such as dense exotic grass (left) and broom (right) have potentially helped with the establishment of the planted natives due to the shelter they provide by reducing exposure to frost and wind in winter and moisture loss in summer.

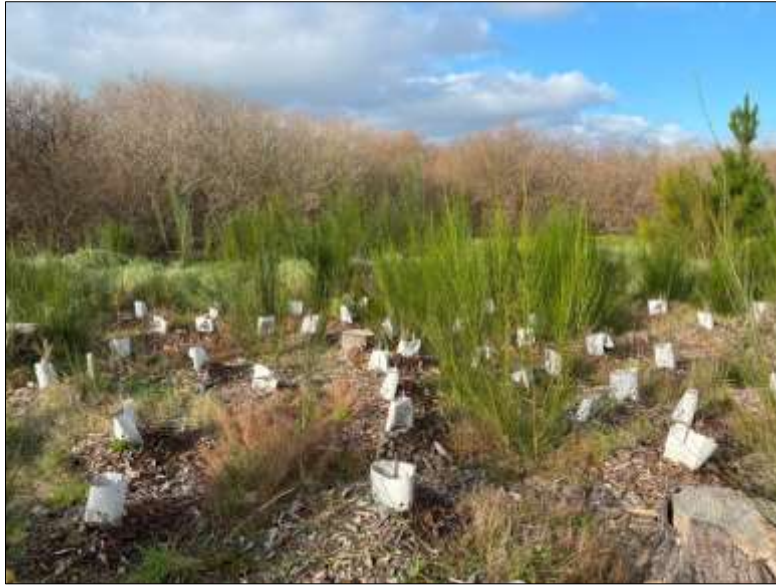
Although some of the surrounding exotic vegetation may be beneficial to the planted native seed islands such as the broom and exotic grass, other exotic species may pose a future threat and challenge to manage like the wilding pine near the edge of the plot. Work is under way through other parts of the site to fell and kill these wildings before they become too big.

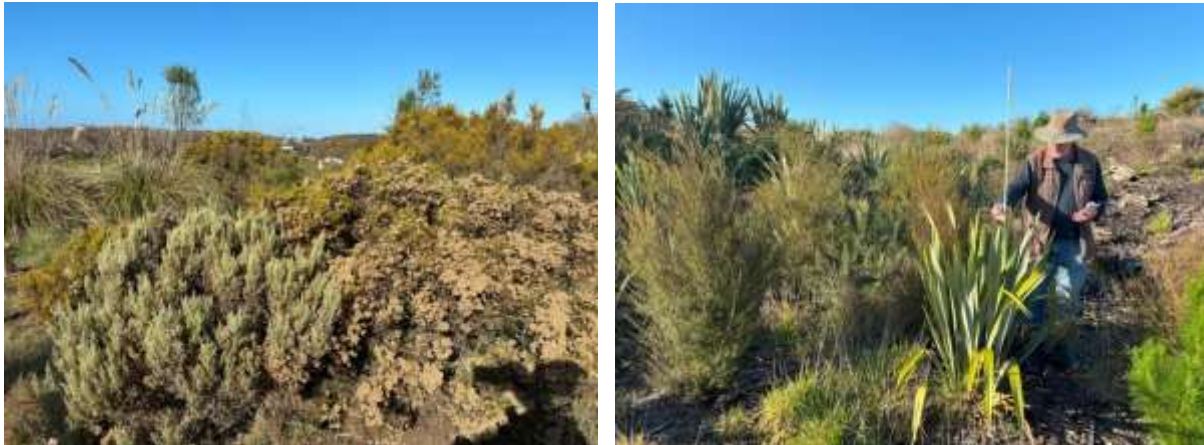
With such a harsh open environment on the mid and back dunes, it is recommended to focus on planting a limited number of the hardiest shrub and monocot species initially to provide shelter for inter-planting and regeneration of other species. These hardy early successional species include tauhinu, harakeke, toetoe, ngāio, ribbonwood, and with rabbit control and more sheltered sites tī kōuka, kōhūhū, karamū, tarata, akeake and koromiko

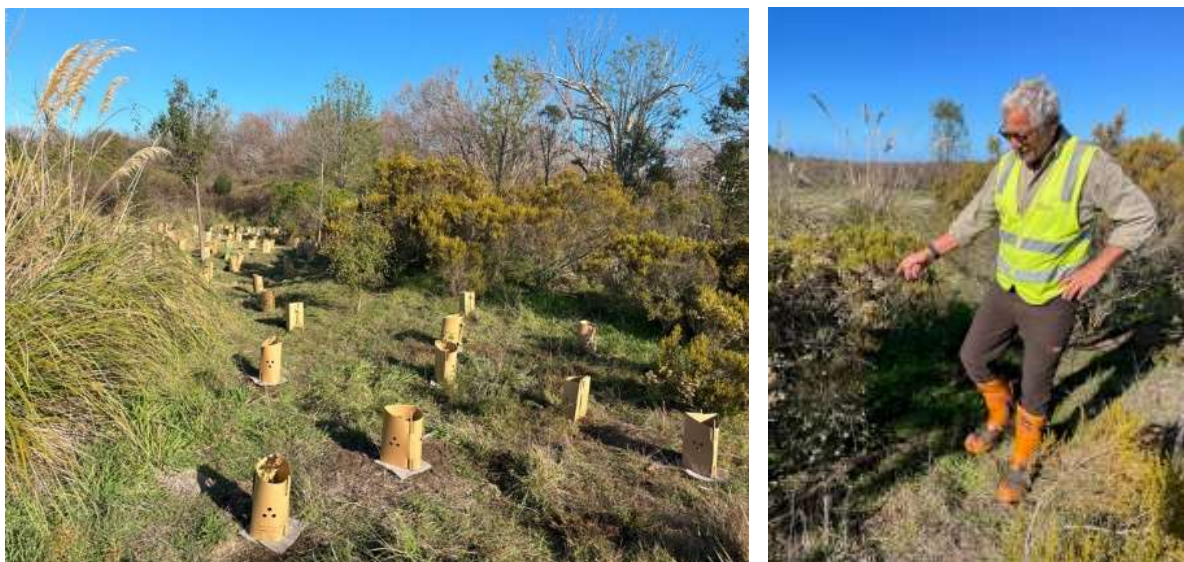
Planting less tolerant native species to increase diversity within the shelter of existing vegetation including established previous native plantings is likely to see more success.

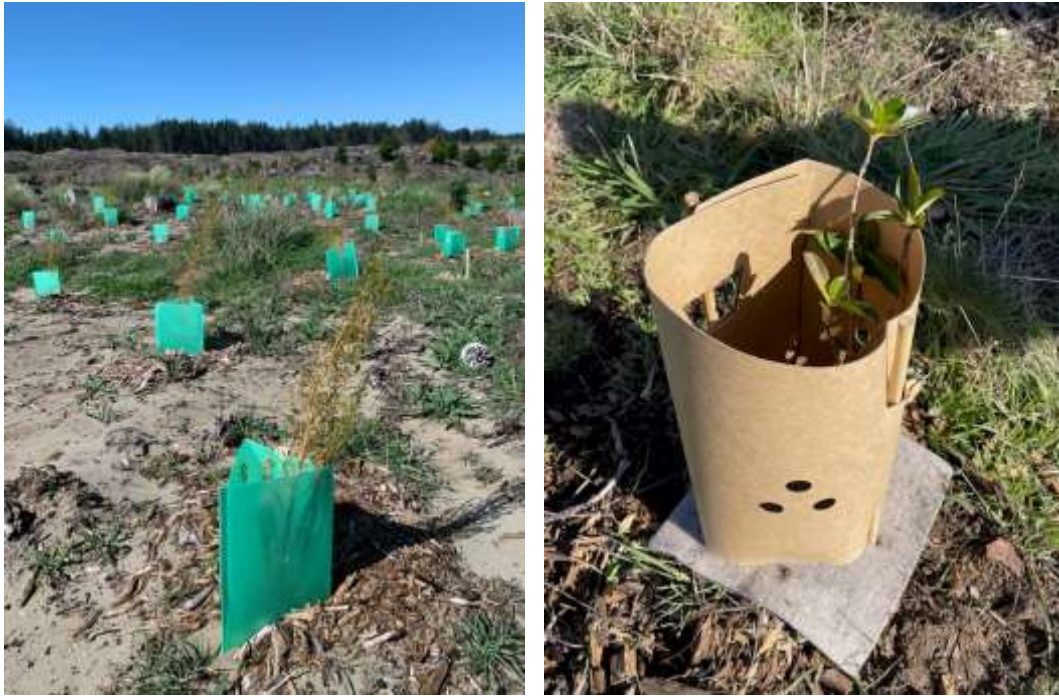
Protecting planted native seedlings from rabbit damage and providing additional shelter is standard practice at Tūhaitara Coastal Park. The use of biodegradable tree protectors, preferably with adequate support from a minimum of 2 stakes to prevent collapse, is now being implemented rather than plastic alternatives.
